Home Value Property Data Report

Type of PDR	Dataset version	LPA Key
ACE+PDR	2.0	
Seller ID	File #	Additional File #
██████████	████████████████████	PDR_6
Property Type		
2-4 Unit

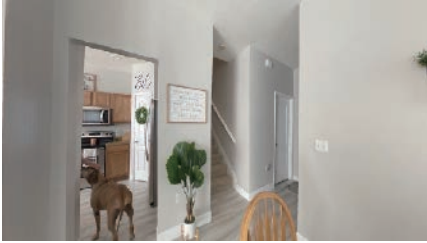
Dining Room Photo

Interior Floor Update Description
New vinyl plank flooring

Interior Walls and Ceilings Update Description
New paint walls ceilings and baseboards

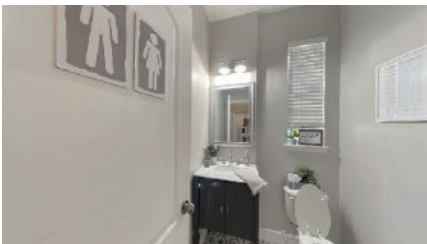
Half Bath Photo

Interior Walls and Ceilings Material	Interior Walls and Ceilings Condition	Interior Walls and Ceilings Updates
None	None	Partially Updated
Interior Walls and Ceilings Update Description		
New paint walls ceilings and baseboards

Estimate Year of Improvement	Description of Improvement
<1 year	New sink and mirror

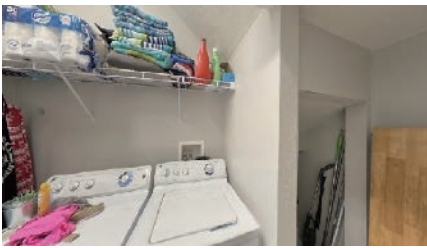
Laundry Room Photo

New vinyl plank flooring

New paint walls ceilings and baseboards

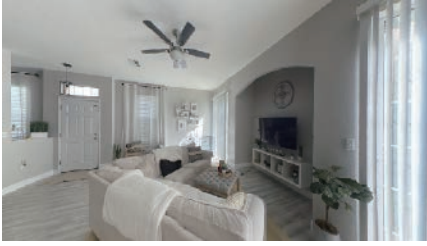
Family Room Photo

New vinyl plank flooring

New paint walls ceilings and baseboards

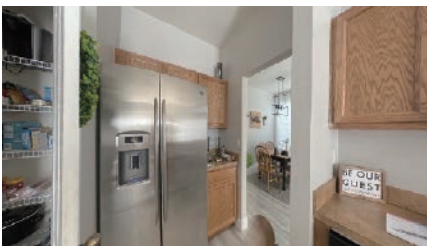
Kitchen Photo

Interior Floors Material	Interior Floors Material Condition	Interior Floor Updates
Laminate	None	Partially Updated
Interior Floor Update Description		
New vinyl plank flooring

Interior Walls and Ceilings Material	Interior Walls and Ceilings Condition	Interior Walls and Ceilings Updates
None	None	Partially Updated
Interior Walls and Ceilings Update Description		
New paint walls ceilings and baseboards

<1 year **New flooring and counter tops**

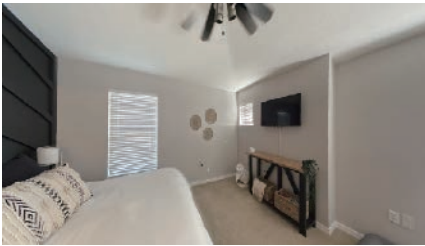
Primary Bedroom Photo

New paint walls ceilings and baseboards

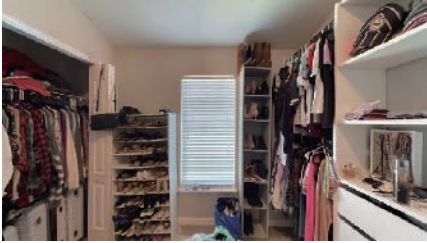
Bedroom 1 Photo

New paint walls ceilings and baseboards

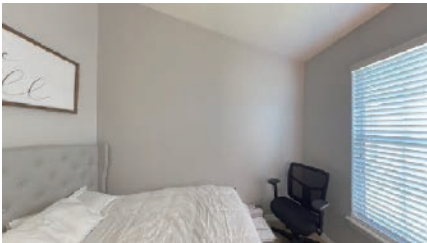
Bedroom Photo

Interior Walls and Ceilings Material	Interior Walls and Ceilings Condition	Interior Walls and Ceilings Updates
None	None	Partially Updated
Interior Walls and Ceilings Update Description		
New paint walls ceilings and baseboards

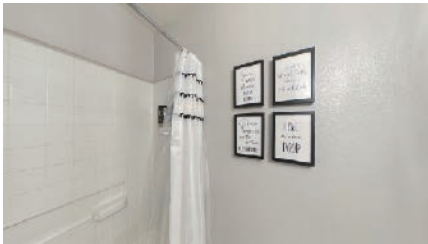
Bathroom Photo

Interior Walls and Ceilings Material	Interior Walls and Ceilings Condition	Interior Walls and Ceilings Updates
None	None	Partially Updated
Interior Walls and Ceilings Update Description		
New paint walls ceilings and baseboards

Estimate Year of Improvement	Description of Improvement
<1 year	New vanity and mirror

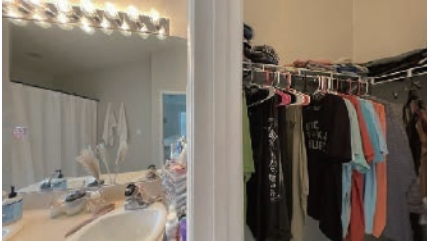
Primary Bathroom Photo

New paint walls ceilings and baseboards
